**Senate Environment and Public Works Committee
Subcommittee on Fisheries, Water, and Wildlife
hearing entitled, “Erosion of Exemptions and Expansion of Federal Control –
Implementation of the Definition of Waters of the United States”
Tuesday, May 24, 2016
Responses for the Record
Mr. Don Parrish**

Don R Parrish
American Farm Bureau Federation

Request for Additional Information: Case Study 1 and Supporting Documents

Case Study 1

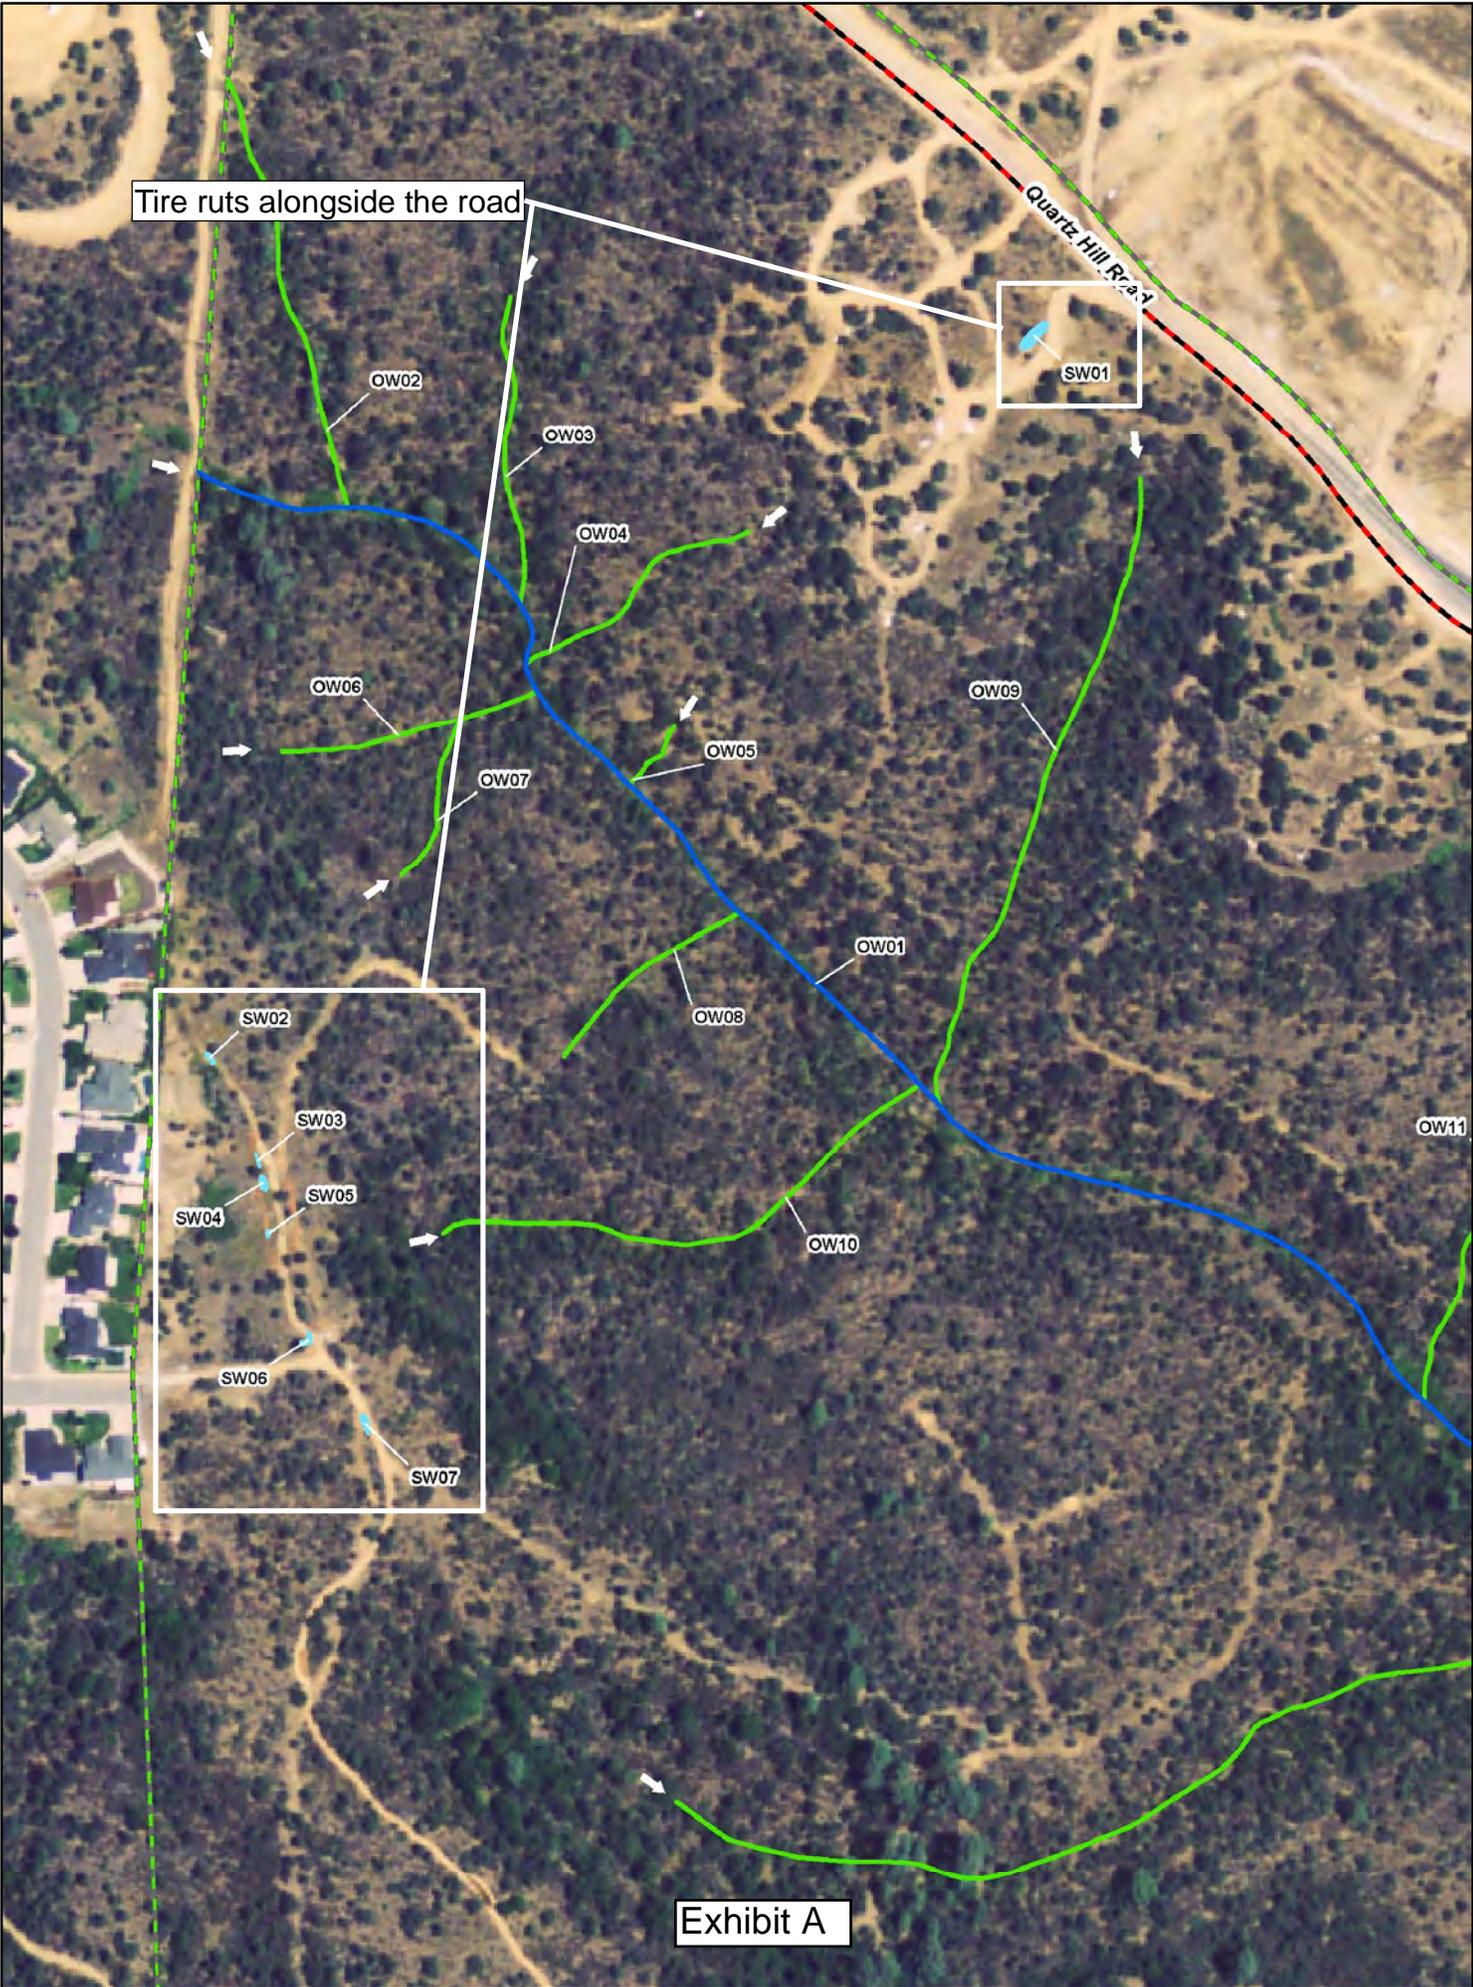
Exhibit A

Tire ruts alongside the road

Quartz Hill Rd #1

4. Details:
 - a. In 2007, a delineation of WOTUS (Exhibit A) was performed for the project area. Of the total 0.214 acres of *Seasonal Wetlands*, 25% of “wetland” features were human created tire ruts in the dirt roads. The consultants argued that the puddles in the dirt roads were not jurisdictional because they did not meet the Corps’ wetland criteria. Specifically, there was an absence of hydric soils and hydrophytic vegetation. Nonetheless, the Corps asserted jurisdiction and required a permit to fill the puddles. Refer to Exhibit B “Field Inspection Form” for the Corps regulator’s reasoning and justification for determining jurisdiction, which includes statements of “little to no veg” and “appears to be formed due to off-road activity.”

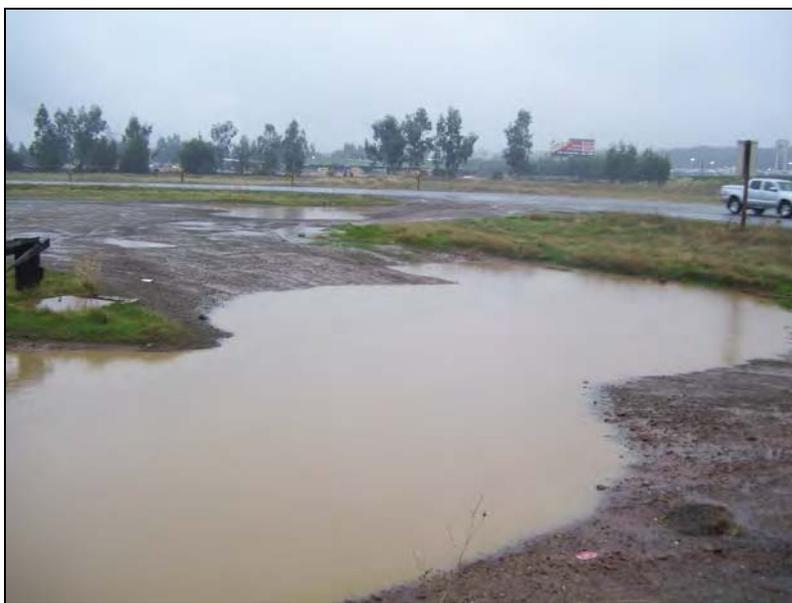
WF 21 looking south

4. Details – The original wetland delineation was revised under the direction of the Corps to include wetland feature 21, a manmade puddle in a gravel parking lot. This revision resulted in an additional 0.079 acres of Seasonal Wetland being labeled as jurisdictional. As observed in Exhibit A, the delineator did not map the puddle in the parking lot as WOTUS. Supporting evidence was provided that the puddle was not jurisdictional. In Exhibit D the delineator provided a series of historical photos that show no connection (isolated) or ponding in the parking lot. However, the Corps later instructed the delineator to map the puddles as WOTUS and suggested language for a data sheet. .Despite arguments from the delineator that the feature is not WOTUS, the Corps asserted jurisdiction and would not verify the delineation map without including the feature. The final map (Exhibit C) shows the puddle in the parking lot. The data sheet (Exhibit E) indicates that no vegetation is present therefore it does not meet the criteria as a wetland. The Corps required Ms. Gallaway to change the data contained in her data sheet and map a feature that did not meet the wetland criteria as a wetland feature as a condition of obtaining a permit. The Corps frequently takes jurisdiction over similar features therefore this situation repeats frequently throughout the region.

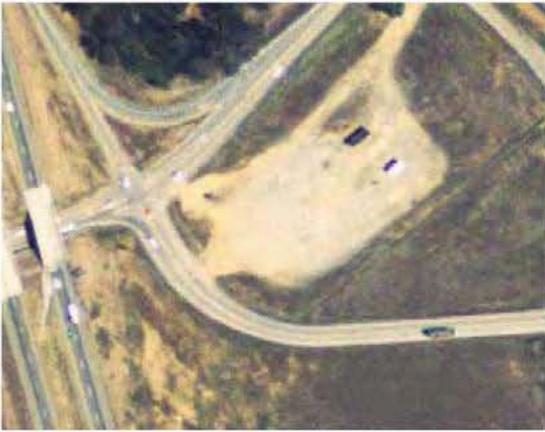
* Aerial imagery showing the absence of wetland feature 21

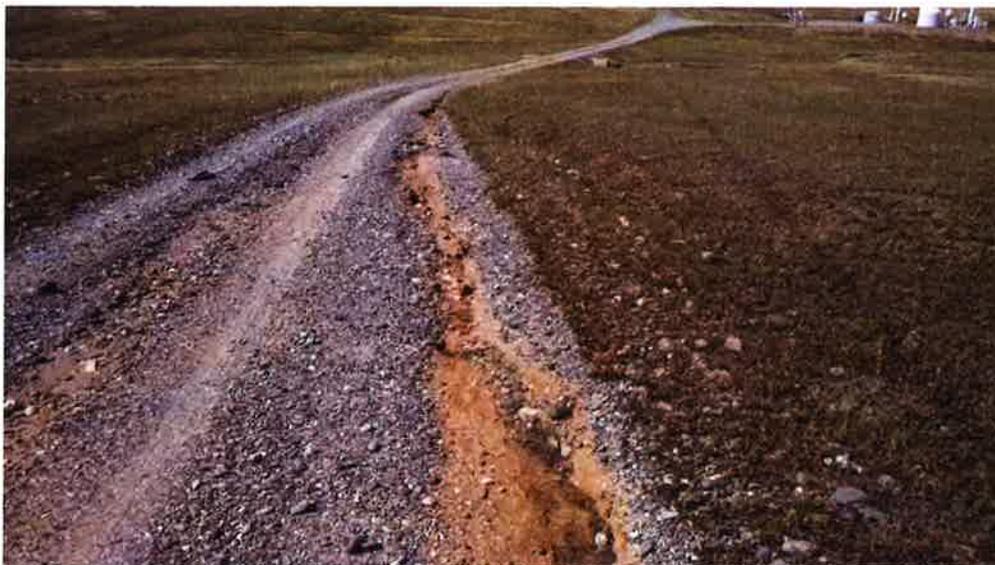
Corps attempted to assert jurisdiction on most of the road side drainages that formed via erosion or were created to construct the road.

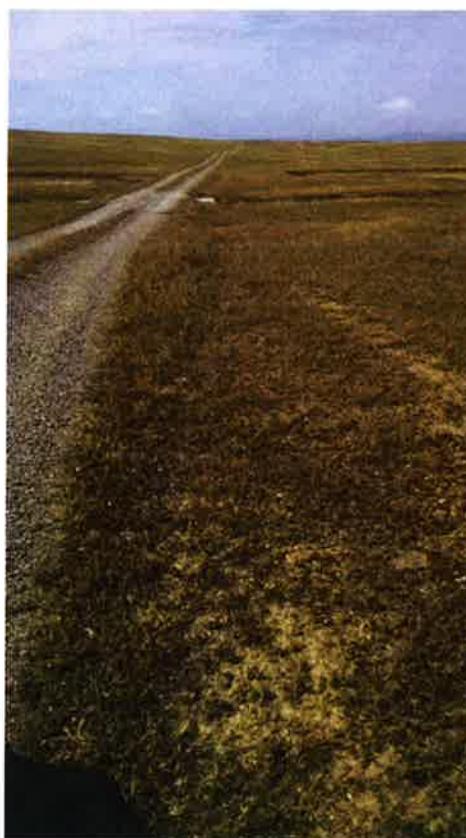
The Corps asserted jurisdiction claiming that sheet-flow was being conveyed in road-side swales even when they lacked bed, bank (ordinary high water mark) or maintained any hydrophytic vegetation (Case study 5).
